S-214
Isaac Harris House or Srittingham Farm
Near Wellington
Private

c. 1780-1798, with c. 1880-1890 addition

Survey No. S-214

Maryland Historical Trust State Historic Sites Inventory Form

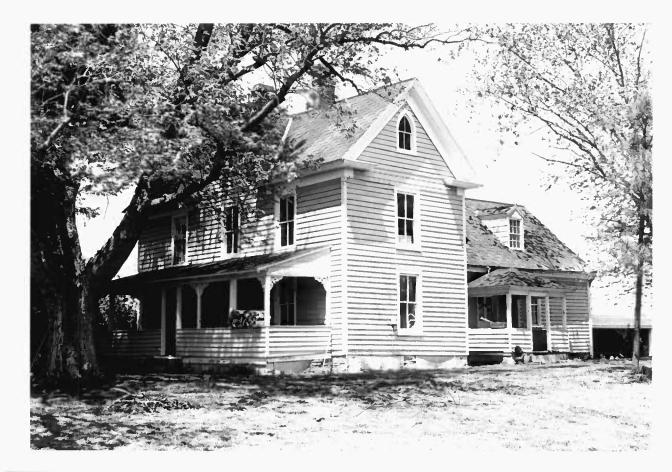
Brittingham Farm
Near Cokesbury, Somerset County
Southwest Elevation
5/84 Paul Touart
Neg./ Maryland Historic Trust

The c. 1880-1890 2½-story three-bay center hall front section rests on a brick pier foundation and is covered by a steeply pitched asphalt tile roof. A cross-gable is centered on the front roof slope. Narrow weatherboards uniformly sheath the exterior, and a shed roof porch extends across the front of the house. Chamfered porch posts and sawn eave brackets support the roof. The fenestration is symmetrical with 2/2 sash windows lighting the first and second floors. A Gothic arch window lights the cross-gable, and a partially glazed paneled door opens into the center hall. Twin corbelled brick chimneys flank the hallway.

The north and south gable ends are alike with a single 2/2 sash window on each floor and a Gothic sash in the gable.

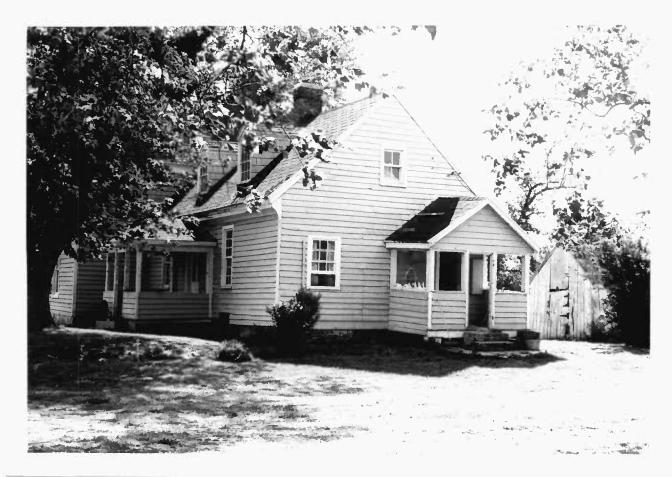
Brittingham Farm
Near Cokesbury, Somerset County
Northeast Elevation
5/84 Paul Touart
Neg./ Maryland Historic Trust

The northeast gable end is sheathed with narrow weatherboards. The remnants of the brick chimney arch is quite visible in the brick rubble foundation. A gable end entrance with gable-front stoop occupies the northern half of the end wall, while a 2/2 sash window pierces the upper story.

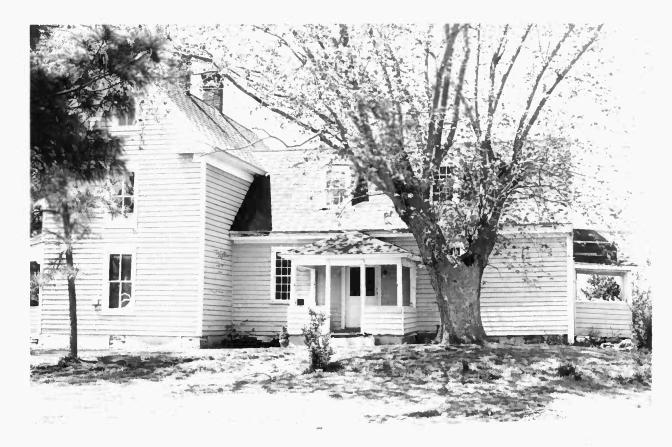
Brittingham Farm
Near Cokesbury, Somerset County
Southeast Elevation
5/84 Paul Touart
Neg./ Maryland Historic Trust

The southeast elevation is three bays across with a center entrance flanked by ⁹ sash windows. The door is a late 19th century replacement but the window sash survive intact with cyma curve surrounds. A hip roofed entrance stoop covers the front door. The boxed cornice stretches across at the base of the roof with crown and bed moldings.

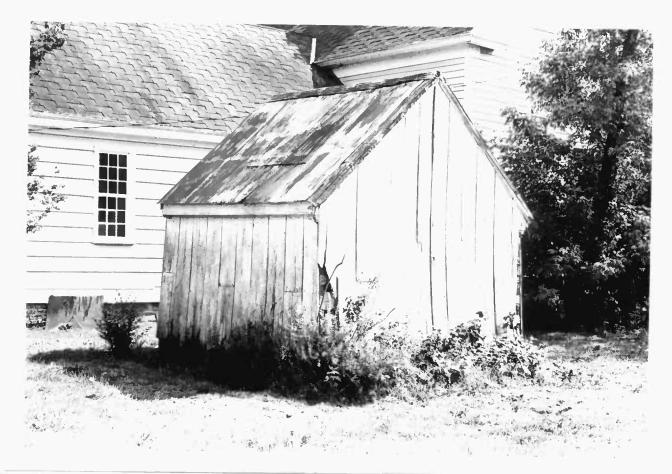
Britting Ham Farm Near Cokesbury Somerset County Northeast Elev.of Smoke House 6/84 Paul Touart Neg./ Maryland Historic Trust

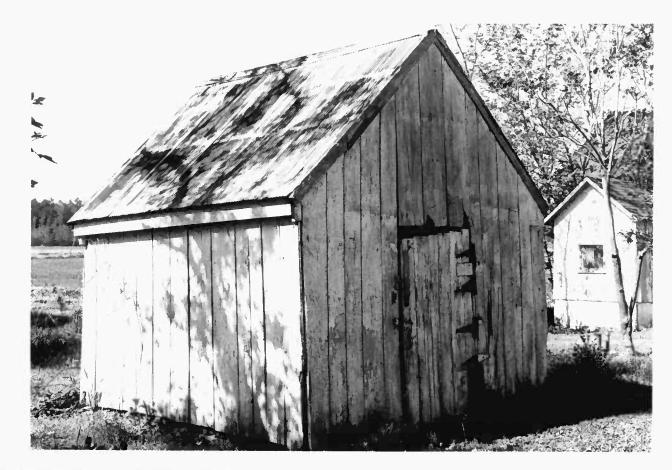
Britting ham Farm
Near Cokesbury, Somerset County
Southwest Elevation - Incoke House
5/84 Paul Touart
Neg./ Maryland Historic Trust

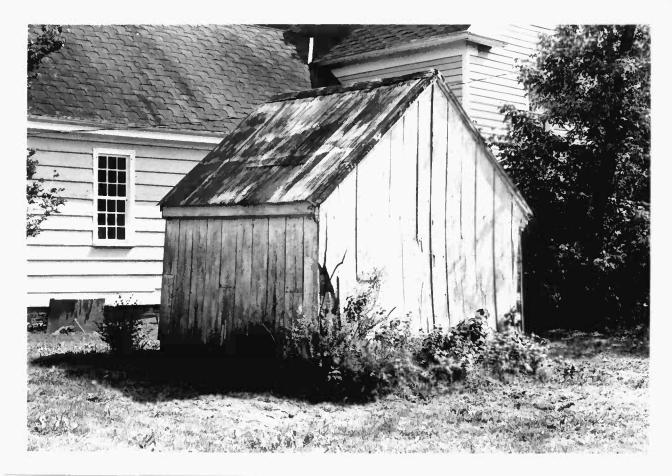
Brittingham Farm
Near Cokesbury, Somerset County
Northeast Elev.of Smoke House
5/84 Paul Touart
Neg./ Maryland Historic Trust

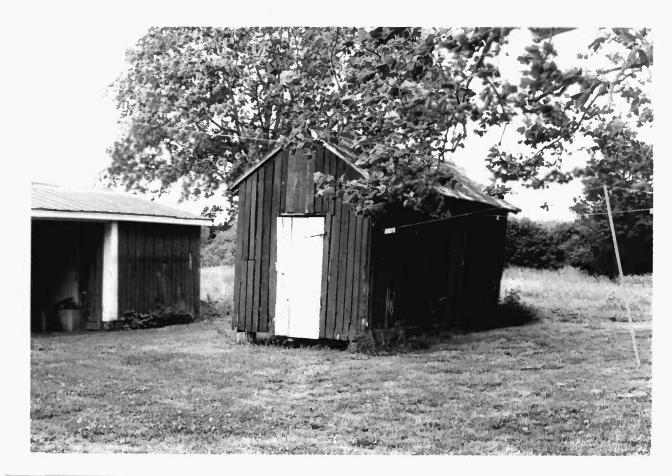
Brittingham Farm
Near Cokesbury, Somerset County
Wagon Shed and Corn Crib
5/84 Paul Touart
Neg./ Maryland Historic Trust

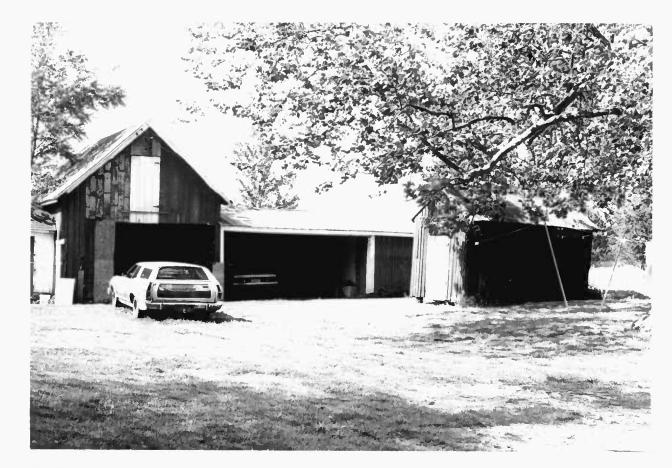
Brittingham Farm
Near Cokesbury, Somerset County
Corn Crib - Southwest Elevation
5/84 Paul Touart
Neg./ Maryland Historic Trust

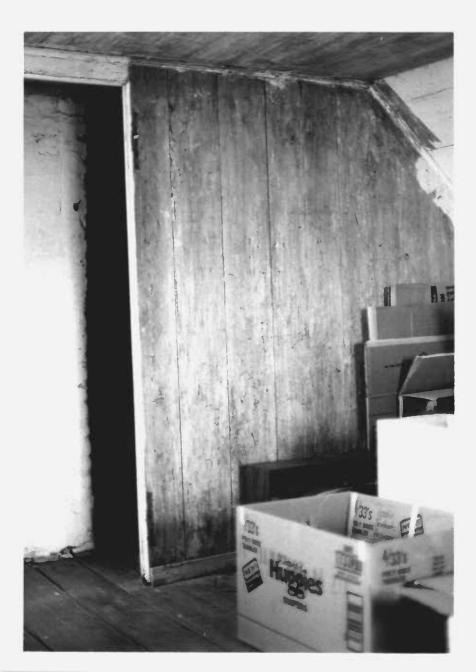
Brittingham Farm
Near Cokesbury, Somerset County
2nd floor partition
5/84 Paul Touart
Neg./ Maryland Historic Trust

The rear service wing is divided as it was in the 18th century by a centrally located vertical board wall. An enclosed winder stair has a four-panel door as well as its early molded surround. In fact most door and window openings retain their original surrounds. A simple post and lintel mantel has been applied to the middle partition for a focal point surrounding the stove.

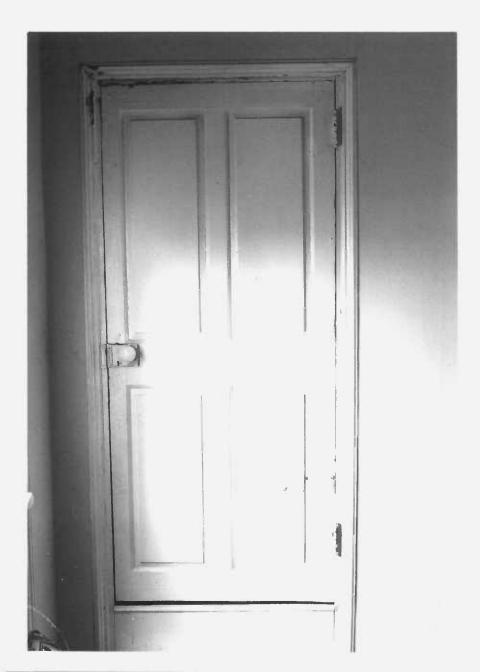
Brittingham Farm
Near Cokesbury, Somerset County
18th-century four-panel door
5/84 Paul Touart
Neg./ Historic Trust

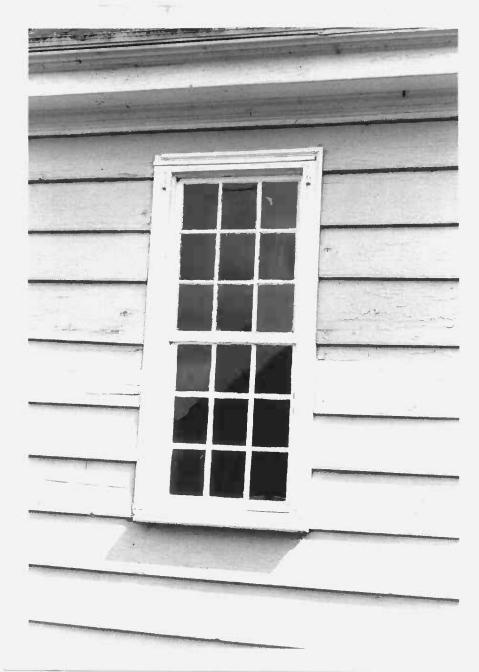
Brittingham Farm
Near Cokesbury, Somerset County
Northwest Elev. 9/9 sash window
5/84 Paul Touart
Neg./ Maryland Historic Trust

The northwest side retains a large portion of its wide beaded weatherboards in addition to the crown and bed moldings of the boxed cornice. The center door has been replaced, but is topped by a five-light transom and framed by a cyma curve surround. Located to either side of the door are early 9/9 sash windows. The foundation walle has been partially rebuilt with concrete blocks. Found within the crawl space was the early mortise and tenon frame wooden grill with vertical diamond-cross sectioned bars.

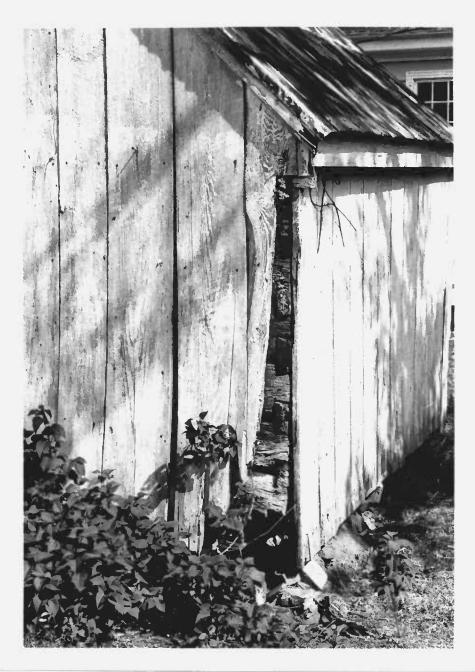
Brittingham Farm
Near Cokesbury, Somerset County
Corner Dovetailing
5/84 Paul Touart
Neg./ Maryland Historic Trust
